Survey No. F-8-121 John Jones House Libertytown, Maryland vicinity Frederick County, Maryland

Maryland Historical Trust HISTORIC PROPERTIES State Historic Sites Inventory Form

John Jones House Libertytown, Maryland vicinity Frederick County

7.1 Description

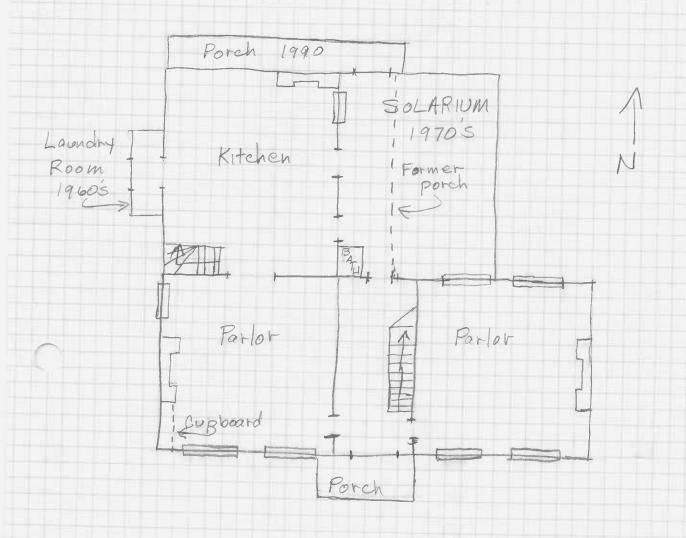
F-8-121 John Jones House Frederick County

Janet Davis July 10, 1991 Not to Scale

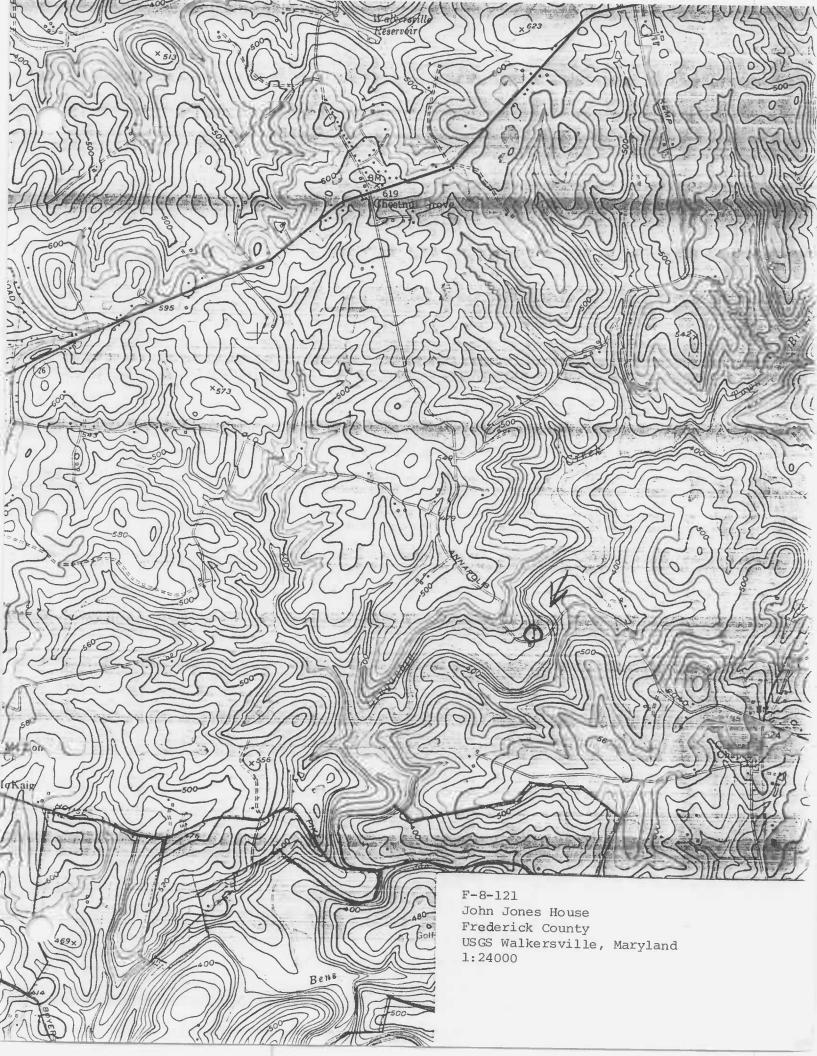
F-8-121 John Jones House Frederick County Photo: Janet Davis July 1991 Nea. bo.: Md. SHPO, Crownsville, Md. South elevation 1/4

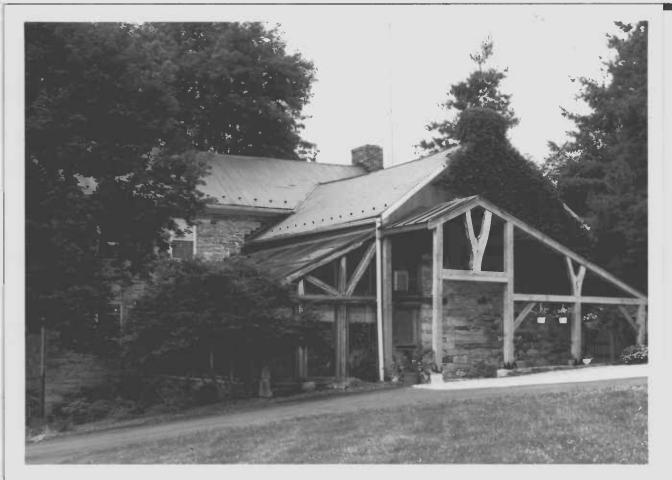
F-8-121 John Jones House Frederick County Photo: Janet Davis July 1991 Neg. foc. i Md. SHPO, Crownsville, Md North elevation 2/4

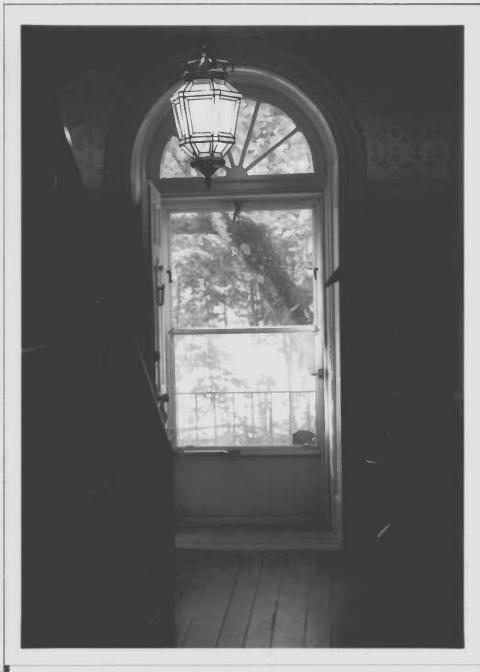
F-8-121 John Jones House Frederick County Photo: Jonet Dovis July 1991 Neg. loc: Md. SHPO, Crownsville, Md Main hall doorway 3/4

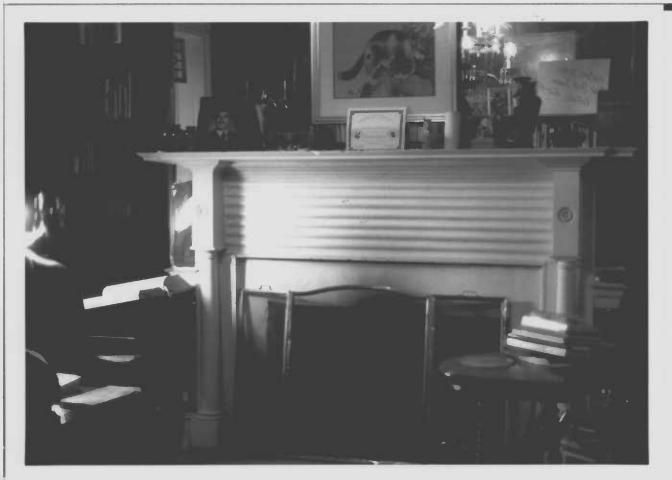
F-8-121 John Jones House Frederick County Photo: Jonet Davis July 1991 Neg. loc. : Md. SHPO, Crownsuille, Md East parlor mantelpiece 4/4
